DISMANTLEMENT OF BUILDING STRUCTURES IN MR REACTOR HALL

NRC “Kurchatov Institute”, Moscow, Russia

The article presents the technologies applied during the dismantlement of building structures and auxiliary systems in the central hall of MR research reactor at the site of NRC Kurchatov Institute. Contaminated structures and systems were mainly removed using remote methods and power-supplied equipment. The latter ones were selected based on safety requirements provided the compliance with the environmental standards that accounted for the location of the reactor in a densely populated area of the Moscow city. The project was aimed at providing the compliance of MR reactor hall with the criteria specified in the decommissioning designs and describing its final state. The paper summarizes the key results and recommendations on the radiation safety of RW management, as well as the lessons learned during the performed operations seeking for their further application at other facilities.

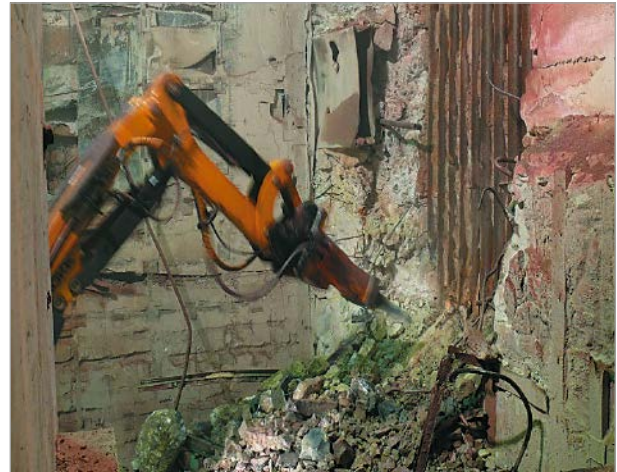
Figure 4 presents the dismantlement stages of the spent fuel storage facility.

Figure 4. Dismantlement of the SNF storage facility

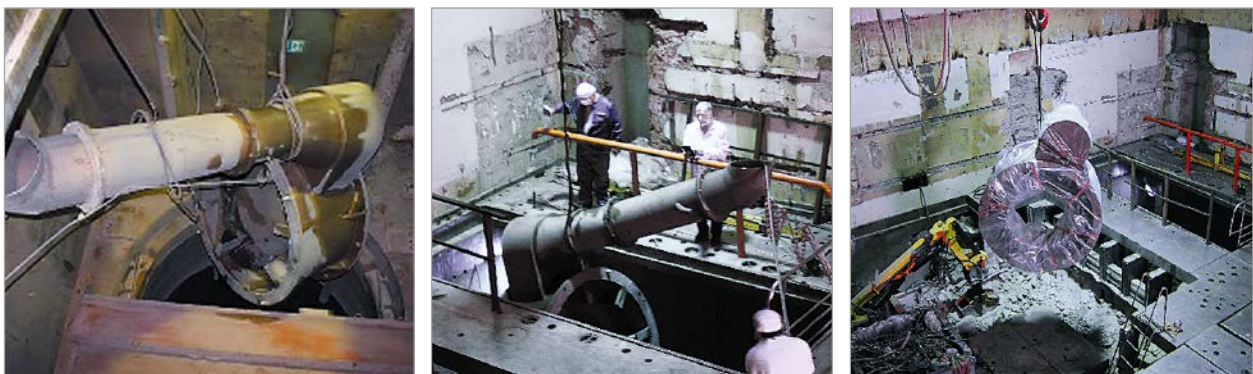
Figure 6. Staged dismantlement of reactor vessel's lower support

The upper part of the structure had a D400 pipeline branch with a pipe outlet going outside the reactor pool. A diamond wire cutting system was used to separate the reactor support from the shaft body. The cutting machine was located at the deck of the pool at an elevation of 0.0 m, the cutting itself was performed at an elevation of -8.0 m. When the pipeline was cut from the lining, the lower support structure was removed from the reactor pool using the bridge crane of the reactor hall. Figure 6 presents the stages in which the operations on the dismantlement of the reactor vessel's lower support were performed.

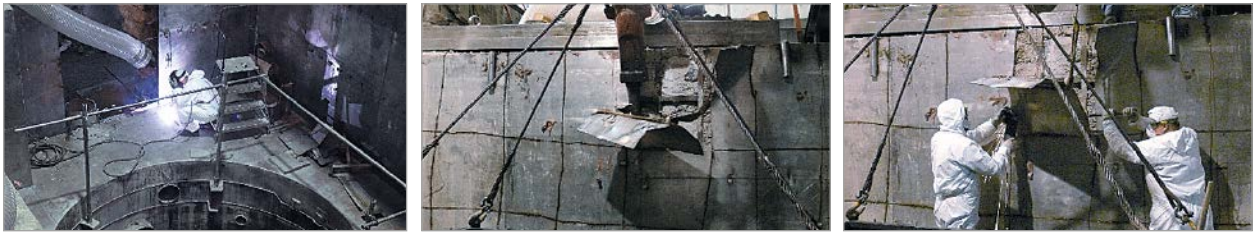
The reactor pool lining was dismantled using a plasma cutting device; in open access areas, the metal was cut using abrasive tools. Remotely controlled BROKK mechanisms (RCM) equipped with hydraulic hammers were used to cut the metal sheets from the biological shielding of the reactor [5]. Figure 8 demonstrates the operations on the dismantlement of the MR reactor pool lining.

Figure 8. Dismantlement of MR reactor lining: using a plasma cutter and RCM BROKK equipped with a hydraulic hammer

A total of ~ 100 tons of metal (stainless steel) radioactive waste resulted from the dismantlement of the reactor pool lining.

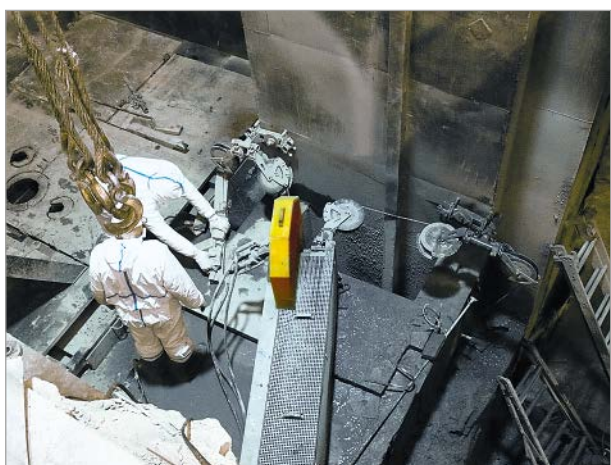
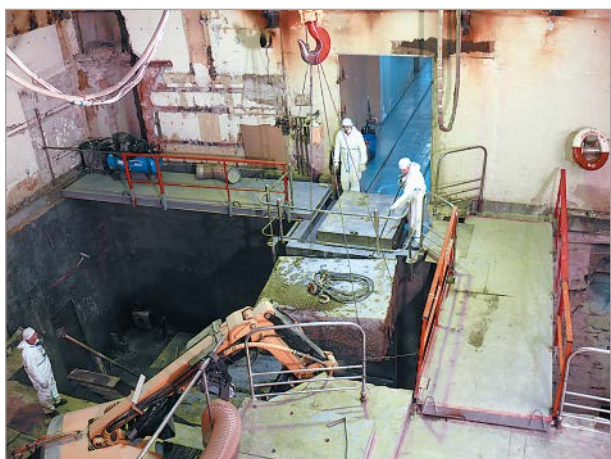
Figure 12. Dismantlement of MR reactor's concrete shielding using a wire rope cutting tool

Figure 12 presents the flowchart followed to dismantle the biological shielding inside the MR reactor.

Both concrete rubble and large fragments were generated during the dismantlement of the biological shielding. Concrete rubble was packed into transport containers and large fragments were transported to a designated temporary storage site awaiting subsequent fragmentation into smaller elements allowing to meet packaging requirements established for the transport containers.
